DAM SAFETY INSPECTION REPORT

LOWER SHAKER LAKE DAM

FILE NUMBER: 1314-001

INSPECTED: MARCH 29, 2023

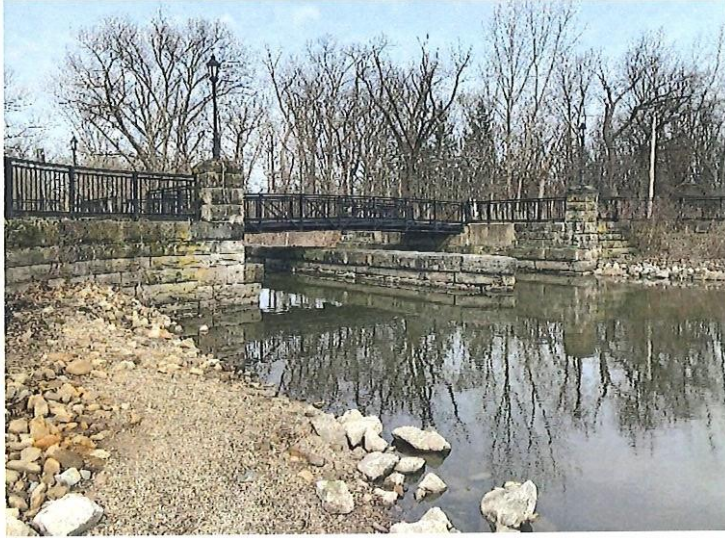
1. Overview of the principal spillway inlet area.

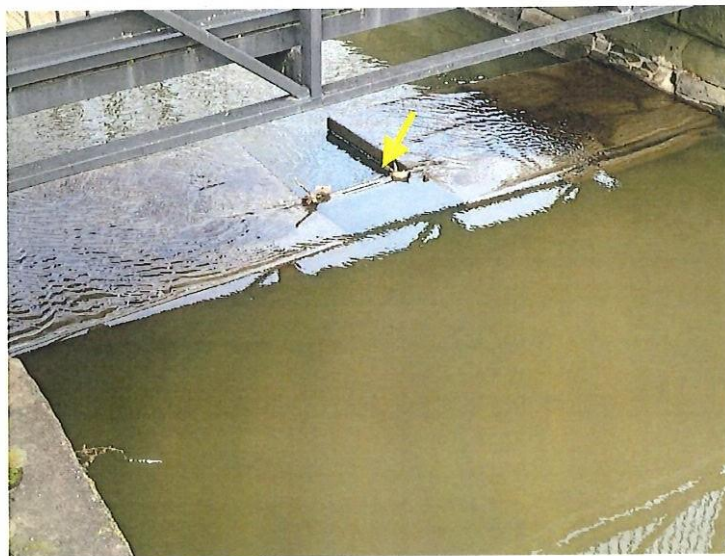
2. Left side of the spillway under the bridge. The arrow points to a flashboard, but its purpose is unclear because the downstream wall is the control.

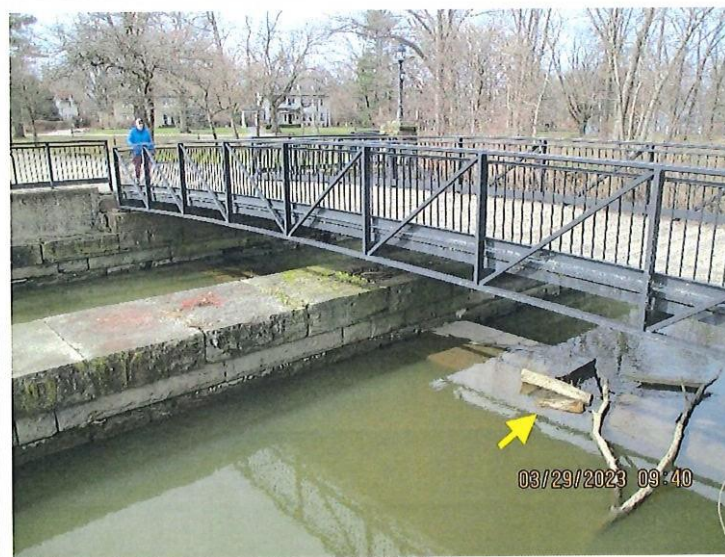
3. Right side of the spillway under the bridge. The arrow points to a flashboard, but its purpose is unclear because the downstream wall is the control.

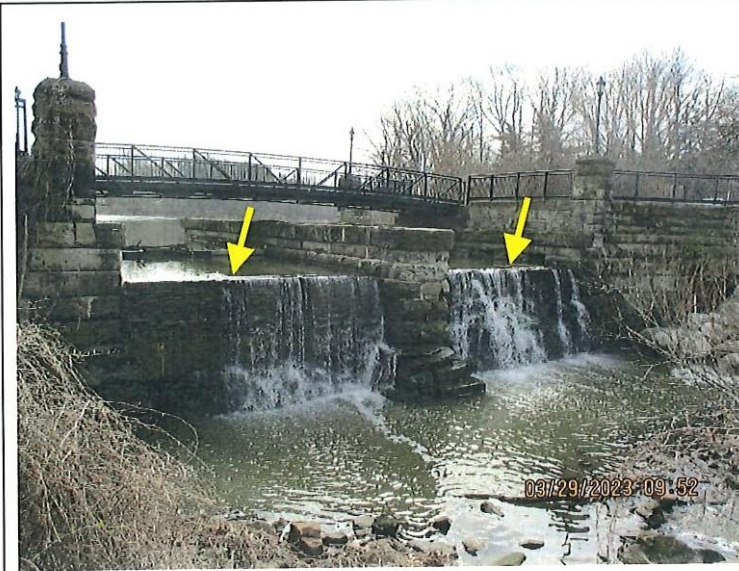
4. Overview of the spillway outlet area. The arrows point to the downstream wall that controls flow.

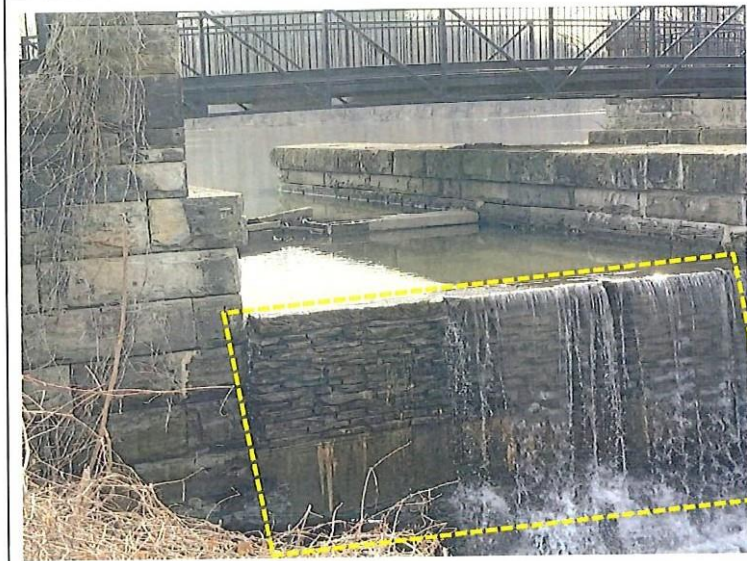
5. The downstream wall on the right side had recently been repaired.

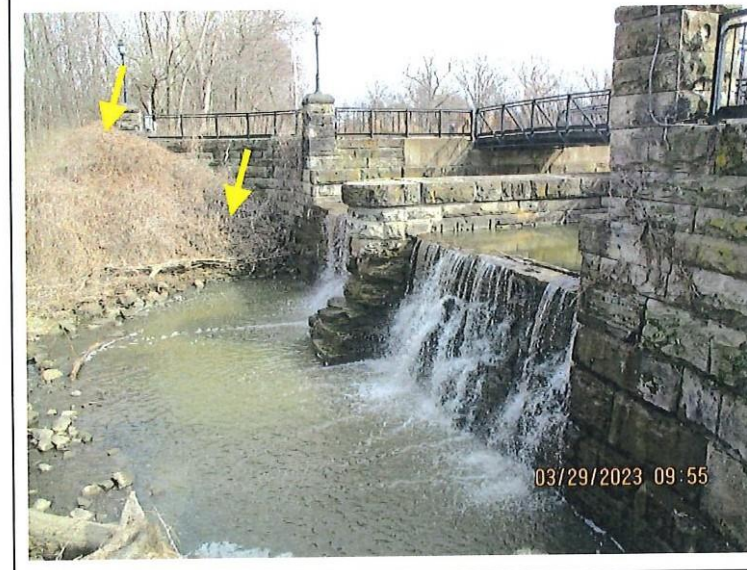
6. Overview of the spillway outlet area. Notice the vegetation by the right sidewall (arrows). The masonry structure was deteriorated and the undermining at the outlet is unknown.

2. Every dam shall have a spillway system which will safely operate during the design flood without endangering the safety of the dam in accordance with OAC Rule 1501:21-13-03. The stability of the masonry principal spillway system must be maintained. Investigate the voids and undermining at the outlet and overall integrity of the structure. Prepare plans and specifications for repair. The condition of the spillway must be monitored quarterly and after severe floods until repairs can be made. This item should be completed in coordination with Item 1 above.

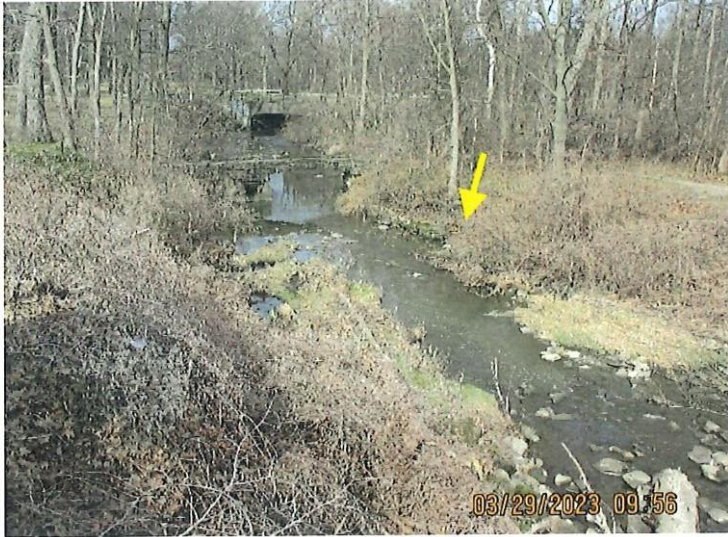
7. Channel downstream of the spillway; arrow points to the lake drain outlet.

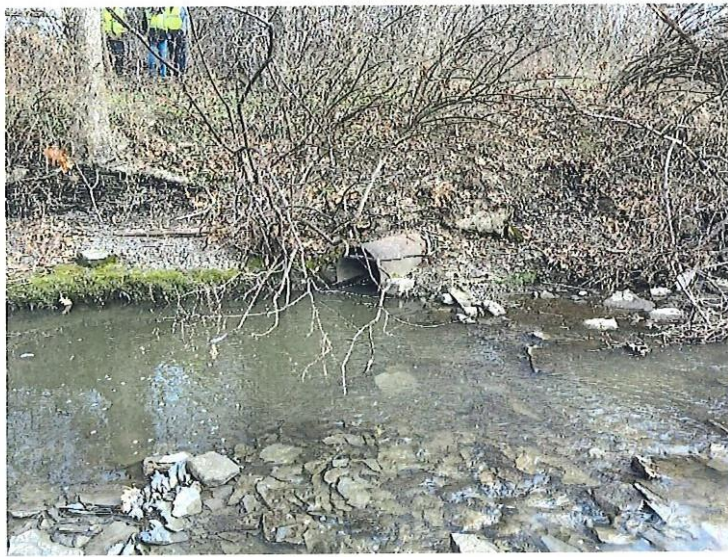
8. Lake drain outlet.

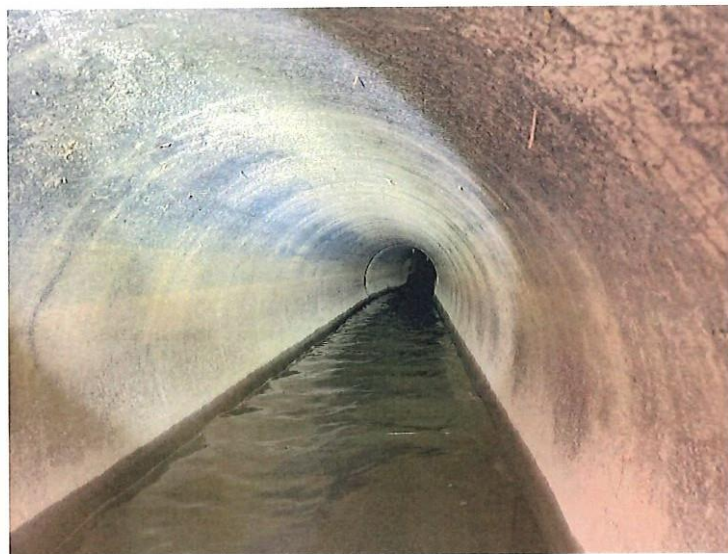
9. Interior of the lake drain pipe.

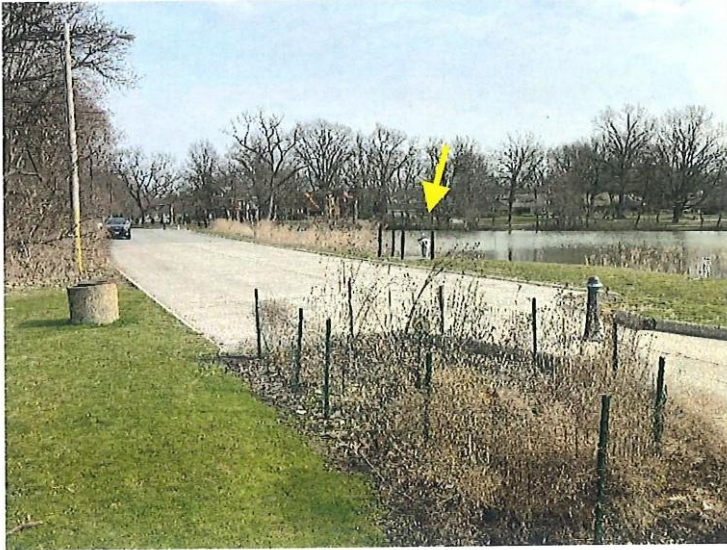
10. Overview of the crest viewed from the right side of the principal spillway. The arrow points to the lake drain well and operator.

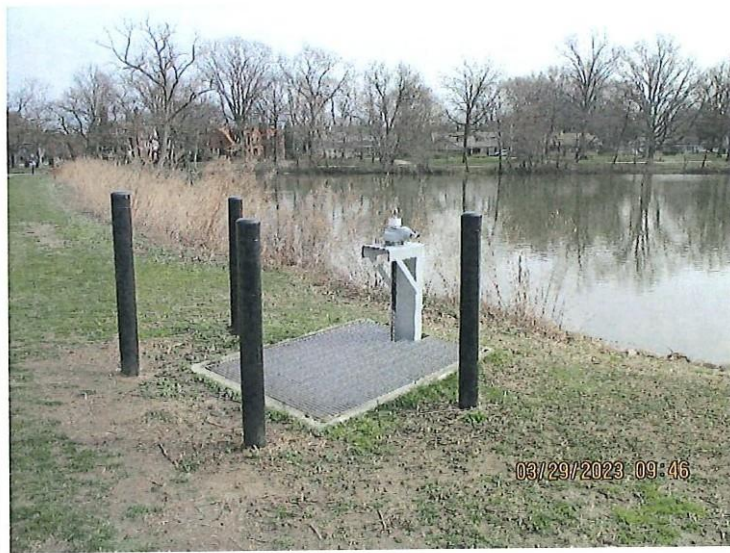
11. Lake drain well and operator.

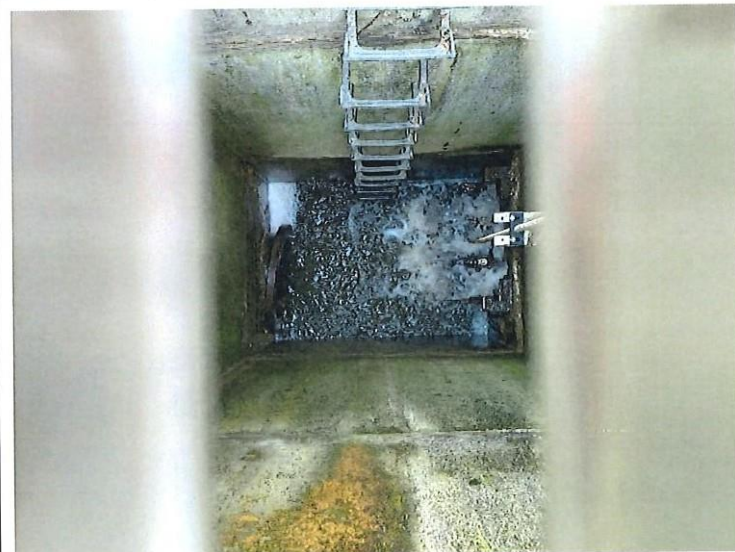
12. Interior of the well; no leakage or obstructions; no noticeable defects with the operator.

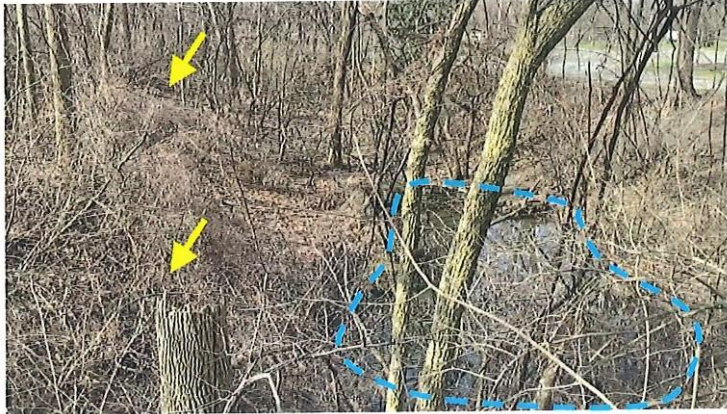
13. Downstream slope viewed from right end of dam; the wet area is circled; arrows point to the downstream slope.

4. Prepare plans and specifications for regrading, and reconstruction as needed, of the downstream slope to repair the damage from tree roots and to facilitate inspection and maintenance. The plans must include alleviating the perpetual wet/poorly drained area at the toe. See the "Trees and Brush" fact sheet for additional information. See Discussion Item 1 of this section for additional information.

3. Monitor the wet area at the right downstream toe monthly for any signs of increased flow, muddy flow, or instability on or adjacent to the embankment. See the "Seepage Through Earthen Dams" fact sheet for guidance and additional information.

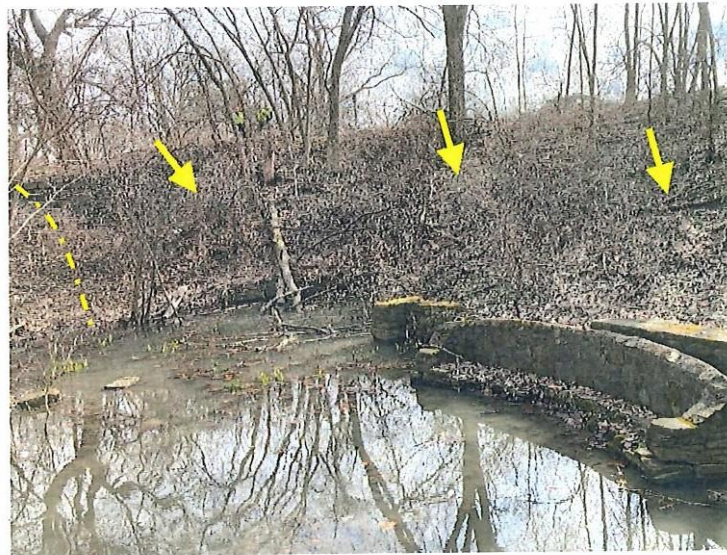
14. Downstream slope viewed from toe looking toward the right end of dam; arrows point to the downstream slope.

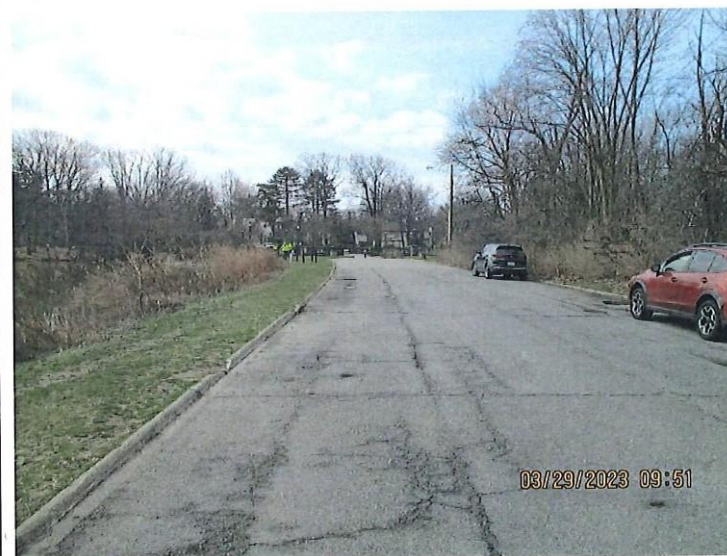
15. Overview of the crest looking toward the spillway.

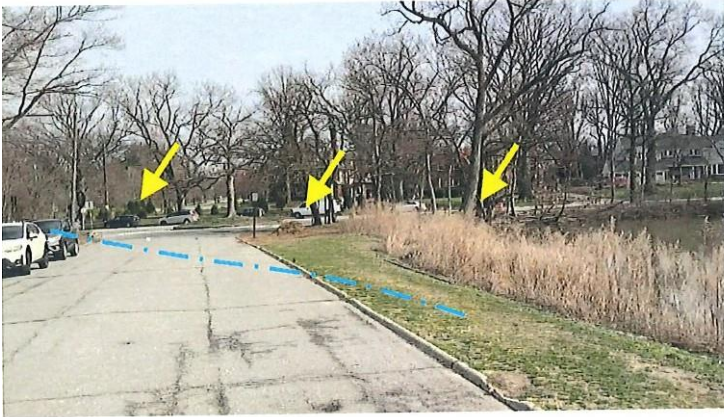
1. The right end of dam is about 2 to 3 feet lower than the main section of the dam. It was reported that the lake overflows and floods North Park Road during severe floods. Other reports have noted that this could be an emergency spillway. If an emergency spillway is

16. Overview of the right end of dam; arrows point to the low area/emergency spillway.

3. The embankment crest alignment must be uniform. Investigate the vertical alignment of the right end of dam crest and prepare plans and specifications remediation. Monitor this area for overtopping during severe floods. This item should be completed in coordination with Item 1 above. See Discussion Item 1 of this section for additional information.

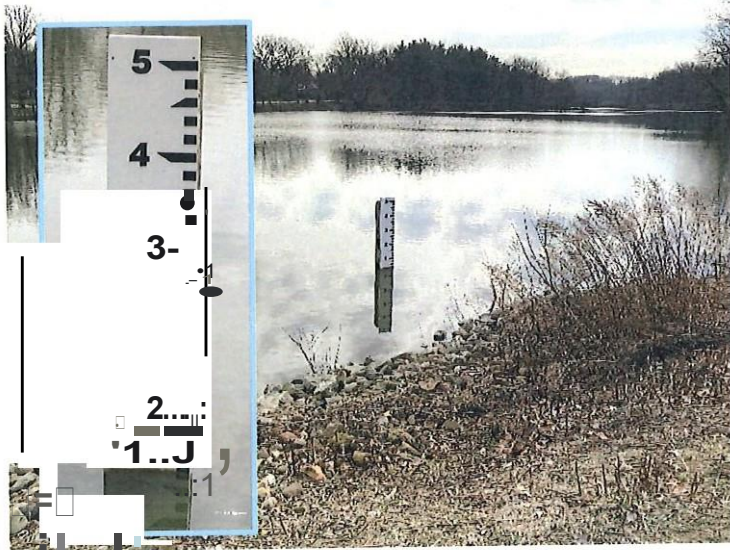
17. Newly installed staff gage. The gage was reading 0.3 foot, and this reflects the stop logs being in place. See Photograph No. 18.

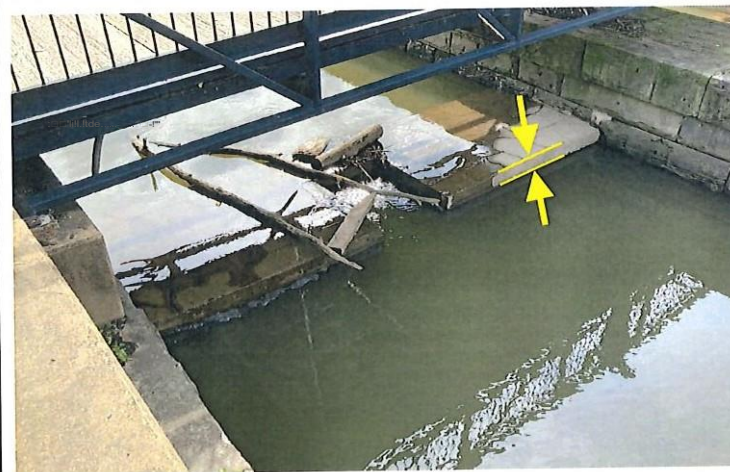
18. Right side of spillway; notice that the stop logs are in place, create about 0.3-foot water surface elevation difference between the pool and the downstream overflow wall.
