DAM SAFETY INSPECTION REPORT

UPPER SHAKER LAKE DAM

FILE NUMBER: 1314-002

INSPECTED: MARCH 29, 2023

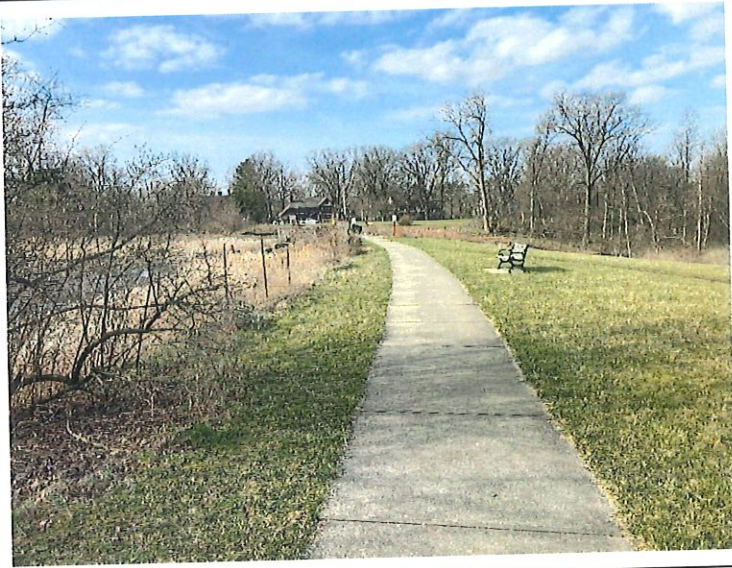
1. Overview from the right end of dam.

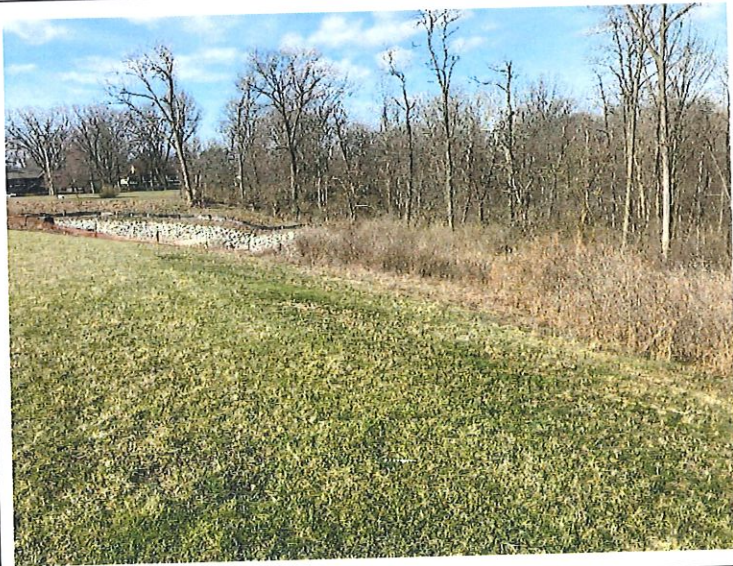
2. Grassed portion of the right downstream slope; notice the vegetation encroaching upon the toe area.

- Right side: good grass cover and rock riprap protection - no problems with erosion
- Right toe area (grassed portion) had brush encroaching onto toe (need to clear another ~25 feet downstream)
- Joe reported that there had been a wet on the right toe area; now covered with rock riprap; no evidence of continued seepage currently, but needs to be addressed
- There were two piezometers (left and right) near the crest; did not appear to be working; need to maintain or abandon
- Seepage previously noted at left downstream end of principal spillway outlet wall not observed, indicating that the lowered pool and grouted conduit have improved this hazardous condition

1. Remove saplings and brush from the toe area of the right downstream slope and from along masonry wall. Seed all disturbed areas to establish a proper grass cover. See the "Trees and Brush" fact sheet for additional information.
2. Replenish rock riprap to repair the eroded areas of the emergency spillway. See the "Open Channel Spillways (Earth and Rock)" and "Outlet Erosion Control Structures" fact sheets for additional information.

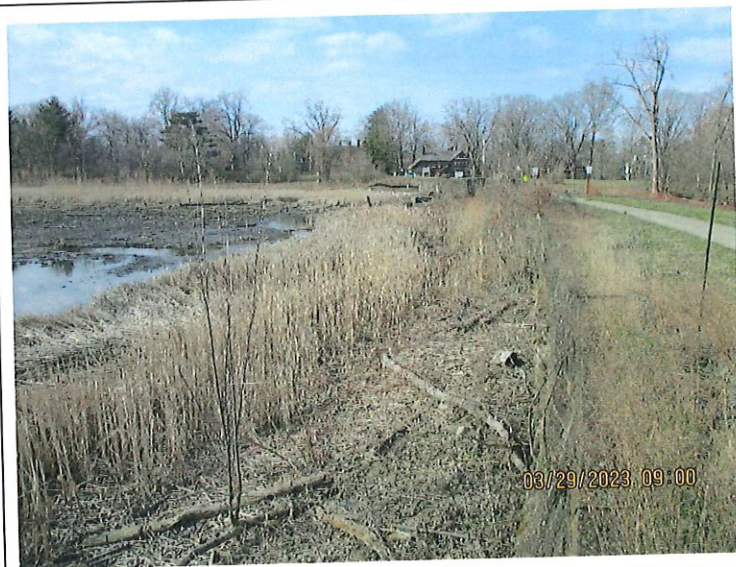
3. Upstream slope looking toward the principal spillway. Notice the tall brush and saplings along the masonry wall (former shoreline).

- Left end of masonry wall was removed for breach channel
- Remaining masonry wall is unchanged; previously found to require engineering repair
- Slope is becoming overgrown (mostly weeds and brush)

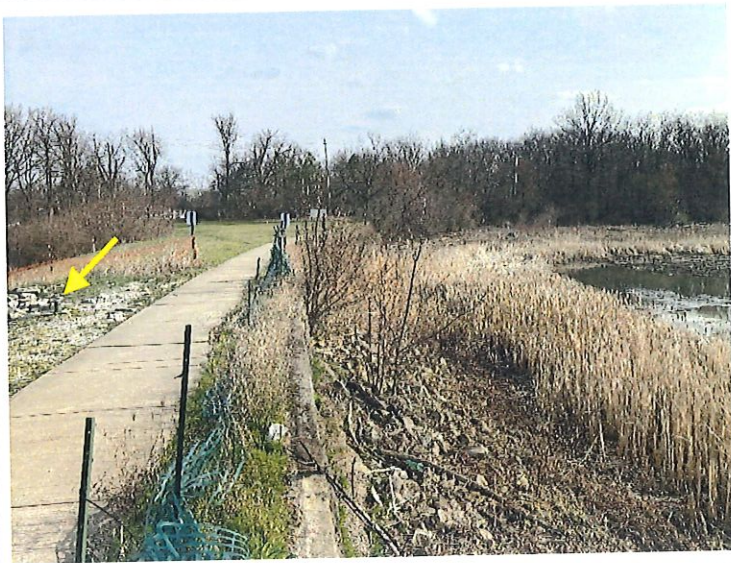
4. Upstream slope looking toward the right end. Notice the tall brush and saplings along the masonry wall (former shoreline). The arrow points to a piezometer.

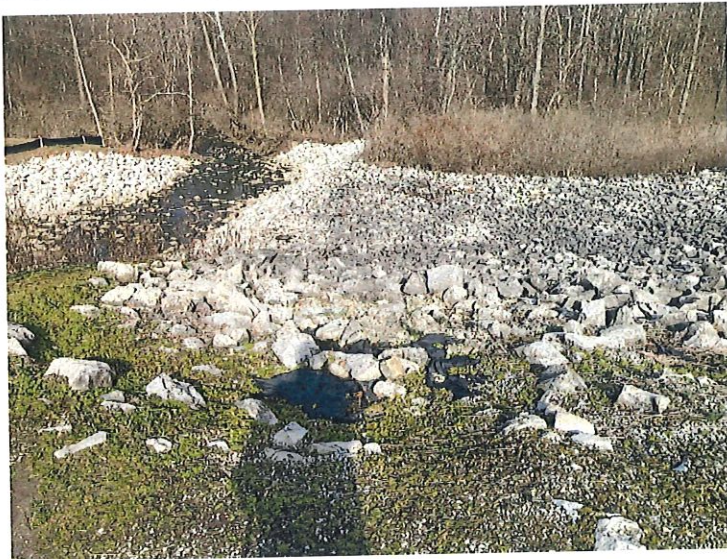
5. Portion of the right downstream slope covered with rock riprap.

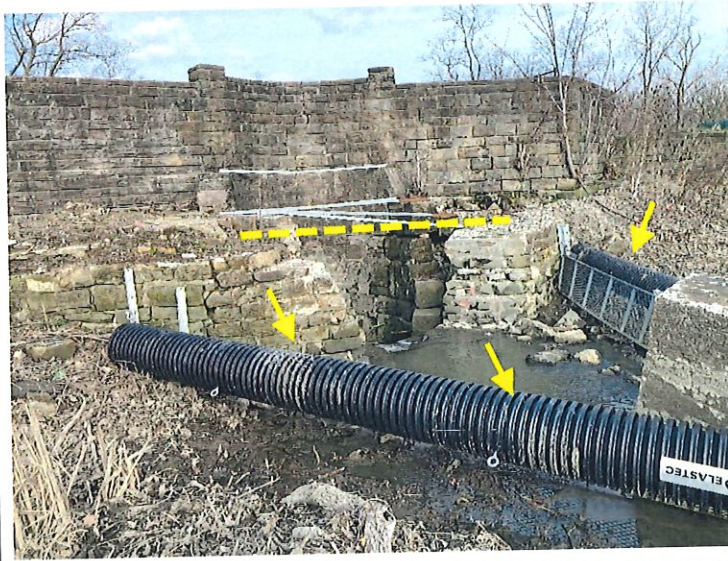
6. Principal spillway inlet area. The dotted line indicates the former normal pool level. The arrows point to the trashrack/debris collection system to keep the low-flow inlet clear.

4. Monitor the principal spillway for seepage when the pool level rises significantly during storm events. Monitoring should include checking the embankment above the spillway for sinkholes and inspecting the outlet area for the recurrence of seepage. See the "Seepage Through Earthen Dams" fact sheet for guidance in monitoring the seepage for additional information.
5. Monitor the principal spillway inlet area for obstructions. Remove debris as needed.

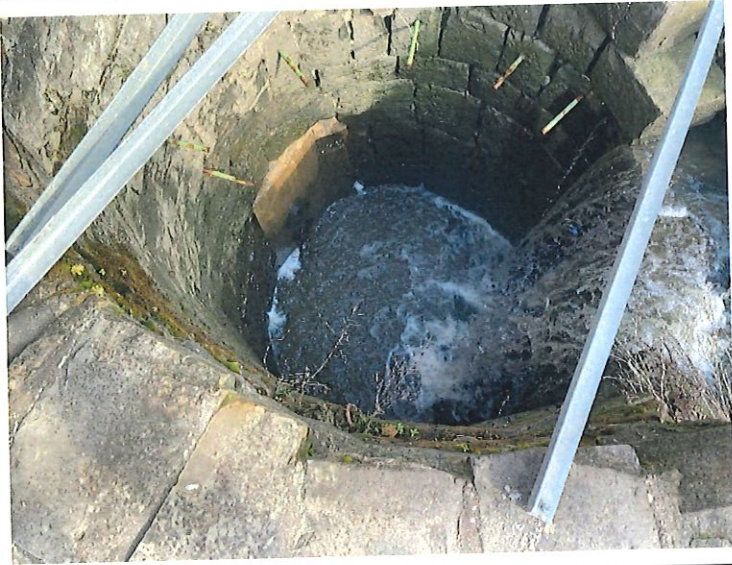
7. Interior of the principal spillway riser; no leakage noted and free of obstructions.

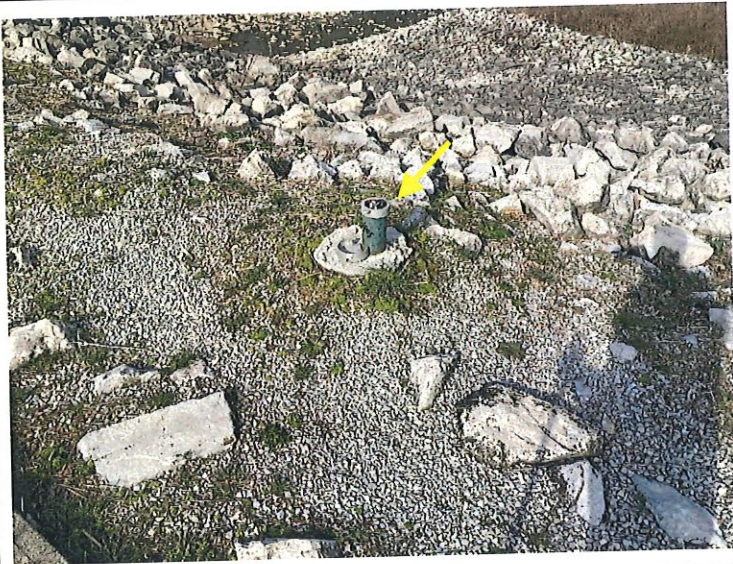
8. Downstream slope to the left of the principal spillway; arrow points to a piezometer.

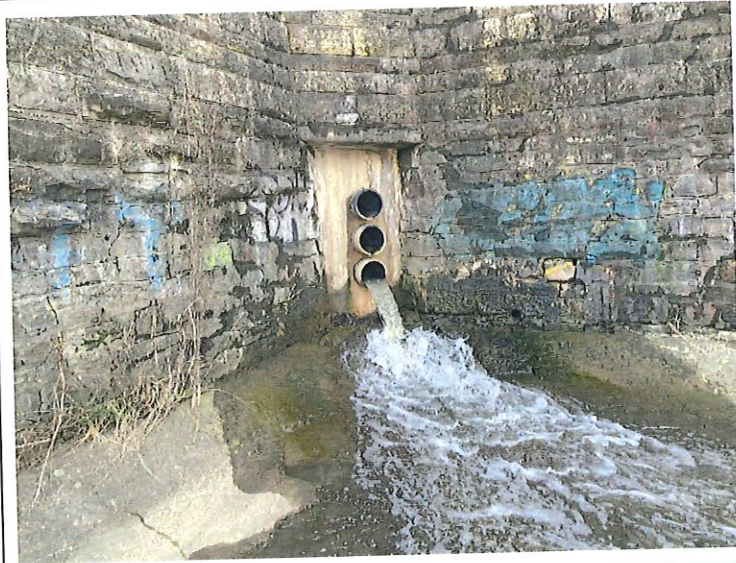
9. Principal spillway outlet.

- Overall, the entire spillway needs to be replaced
- The spillway has been modified to lower the pool level and diminish the potential for erosion along the discharge conduit. No problems with the recent modifications were noted. All discharge pipes were unobstructed
- The modified spillway should continue to be monitored for the recurrence of seepage and clogging, especially during flood events

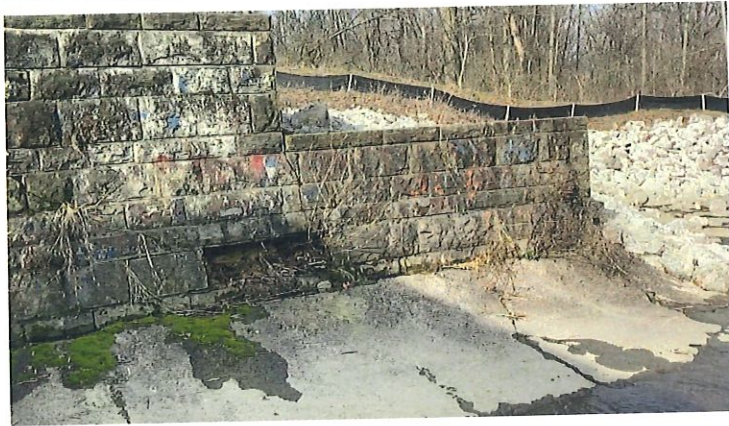
10. Left sidewall at the principal spillway outlet; seepage has been reduced compared to previous observations (see Photograph No. 11)

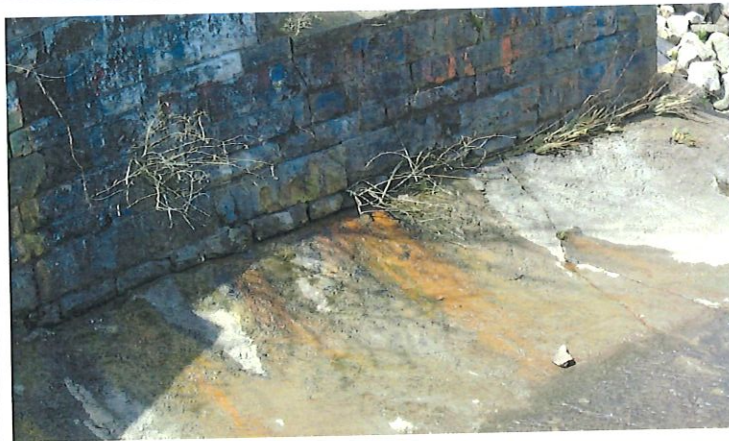
11. Photograph from April 18, 2018; iron staining is indicative of seepage.

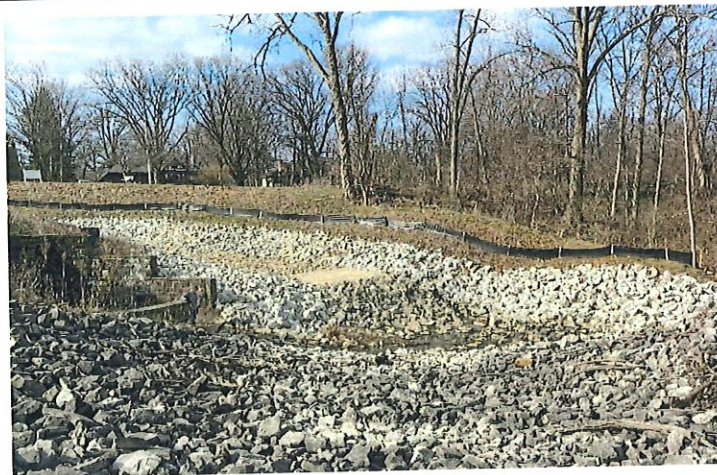
12. Overview of the area where the principal spillway and emergency spillway combine to flow into the receiving stream.

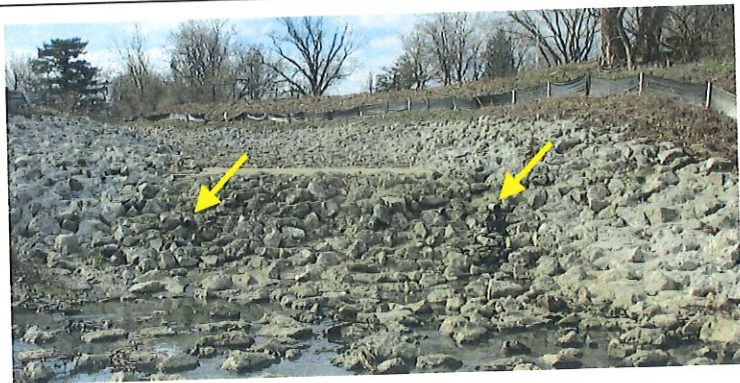
13. Emergency spillway outlet; arrows point to the underdrain outlets; left (referenced looking downstream) had trickle flow, and the right was dry.

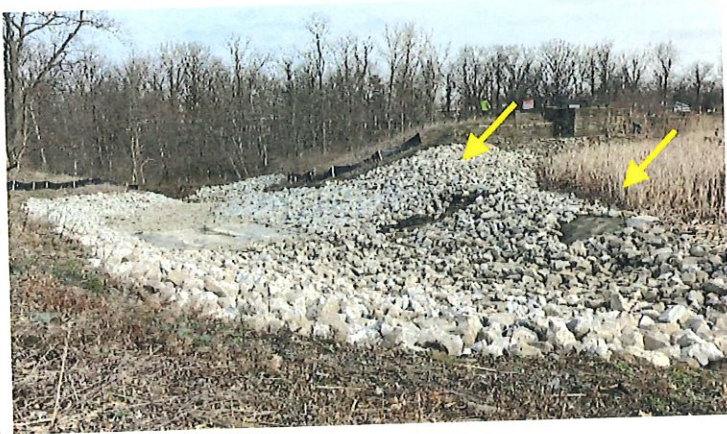
14. Emergency spillway channel inlet area; arrows point to eroded areas.

- An eroded area about 4 feet deep, and 6 feet in diameter was located about 15 feet upstream of the grouted rock riprap on the right side of the inlet area; there was also exposed filter fabric in this area
- The overall channel was in good condition
- There was a trickle flow from the left underdrain outlet and the right underdrain outlet was dry

3. Monitor the emergency spillway for erosion during and after flood events. See the "Open Channel Spillways (Earth and Rock)" and "Outlet Erosion Control Structures" fact sheets for additional information.

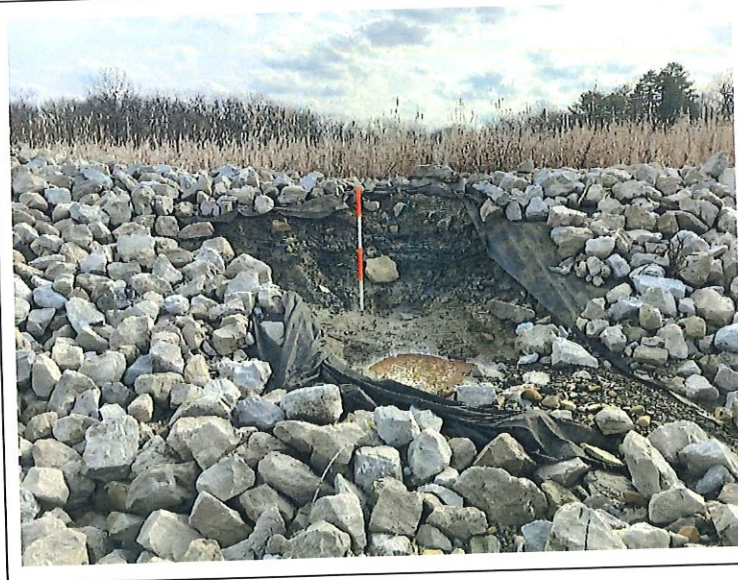
15. Close up an eroded area.

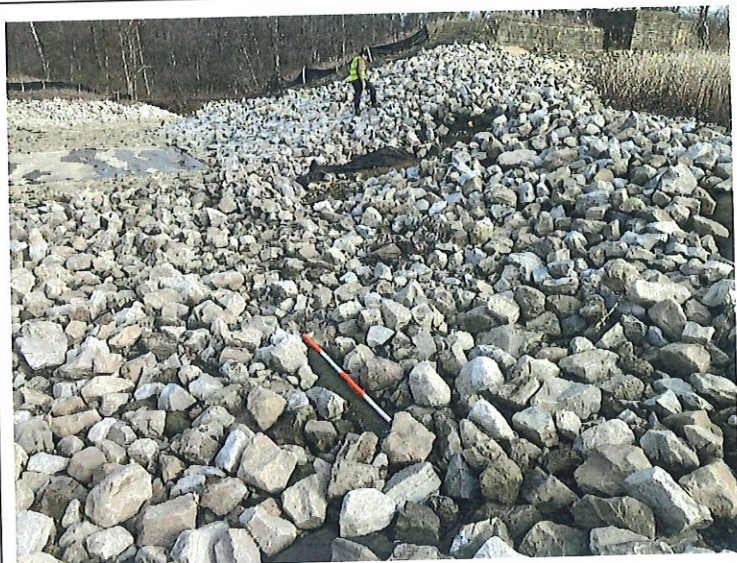
16. Area where rock riprap had been eroded and the underlying filter fabric was exposed.

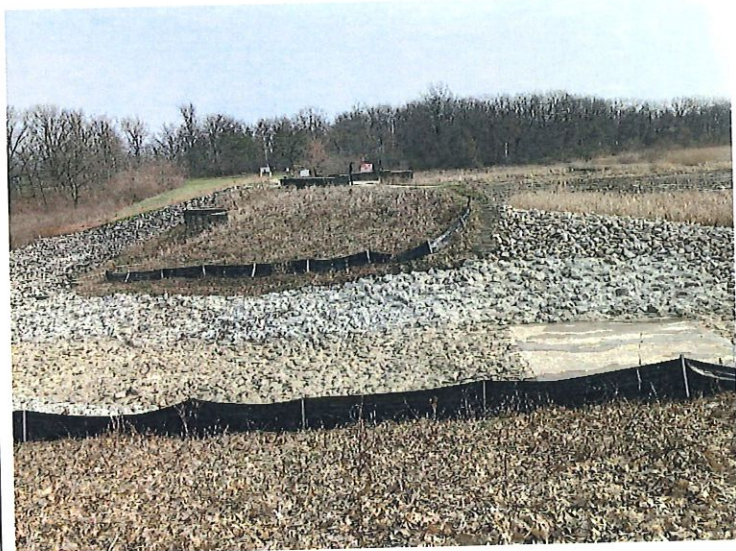
17. Overview of the emergency spillway channel.

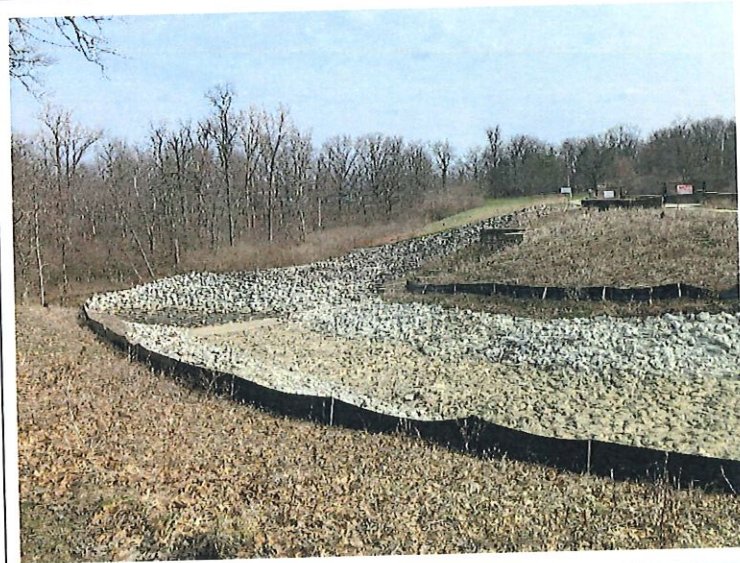
18. Overview of the emergency spillway channel.
