# **The Doan Brook Handbook**

Laura C. Gooch

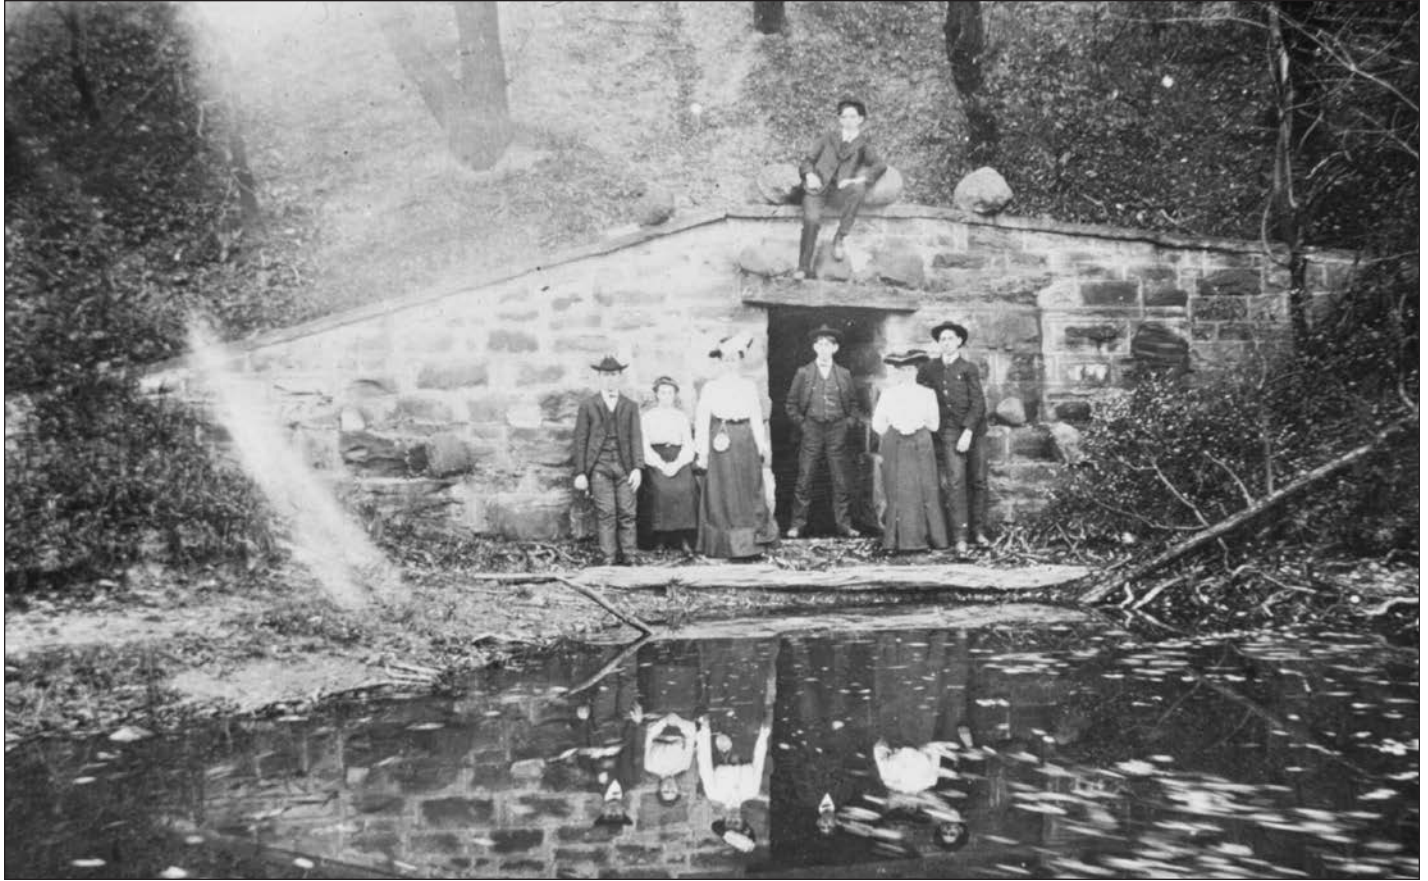
Horseshoe Lake dam from downstream – 1900. Photograph by L. Baus. From the collection of the Nature Center at Shaker Lakes.

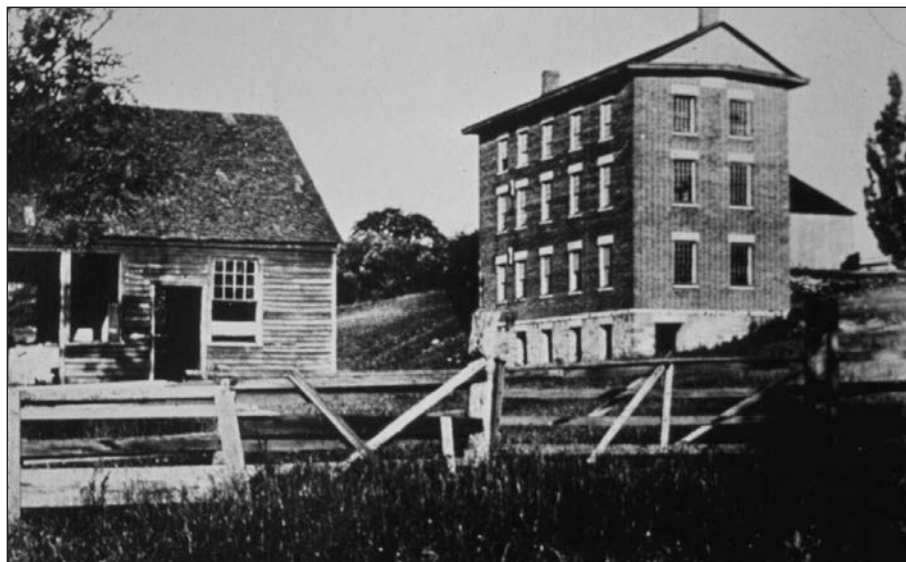
**Figure 2-6** Shaker Woolen Mill

Built in 1854 in the northwest quadrant of what is now the intersection of Lee Road and South Park Boulevard. Photographer unknown. From the collection of the Nature Center at Shaker Lakes.

At the beginning of the 1850s, there was great demand for Shaker-manufactured brooms and woolen goods. The Elders at North Union decided to build a powered woolen mill and broom shop to meet the demand. Once again, their power source was Doan Brook, and in 1852 they built a dam on the brook to form Horseshoe Lake. This dam, which was enlarged in 1854, was an impressive stone structure with a finished stone spillway and ashlar-stone upstream face. Although it has been modified and repaired many times, traces of the original dam can still be seen. Water from the dam was carried to the woolen mill via a series of wooden troughs along the south side of the brook valley. At the woolen mill (see Figure 2-6), located just east of Lee Road and north of South Park Boulevard, the water turned an overshot wheel, which in turn powered machines for carding, spinning, and weaving wool and lathes for turning broom handles.

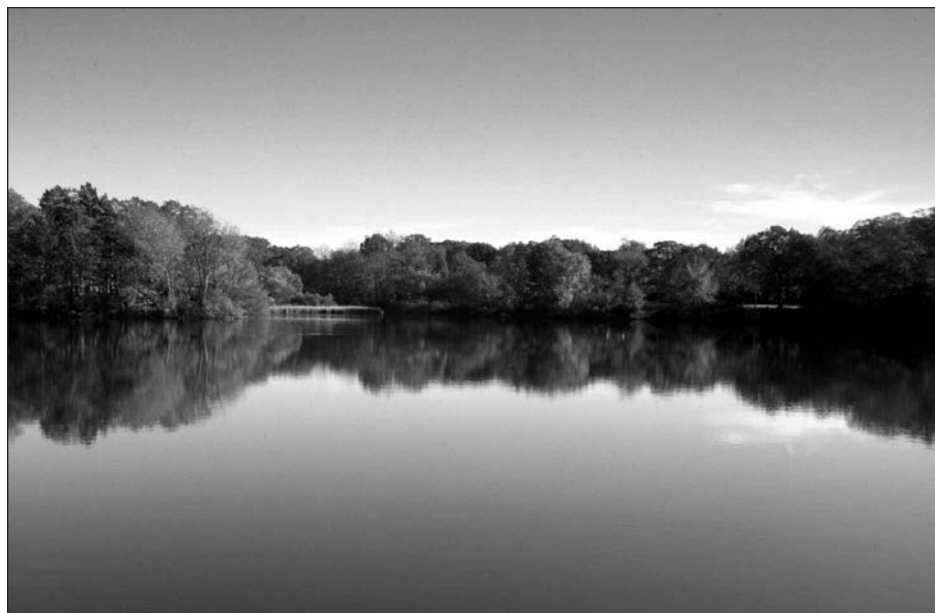
**Figure 3-2** Horseshoe Lake lies at the confluence of the north and middle branches of Doan Brook. Photograph by L. C. Gooch.

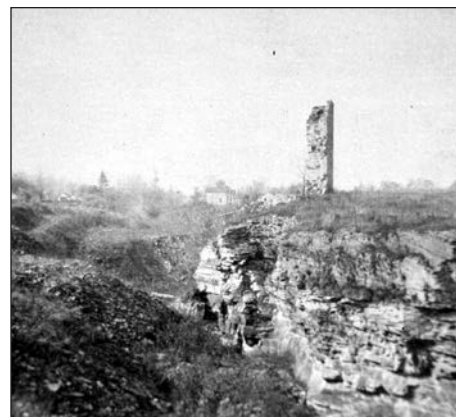
**Figure 4-1** This photograph of the Doan Brook gorge near North Park Boulevard and Delaware Road in 1894 demonstrates that the land was almost completely cleared by early settlers. Photographer unknown. From the Nature Center at Shaker Lakes collection.

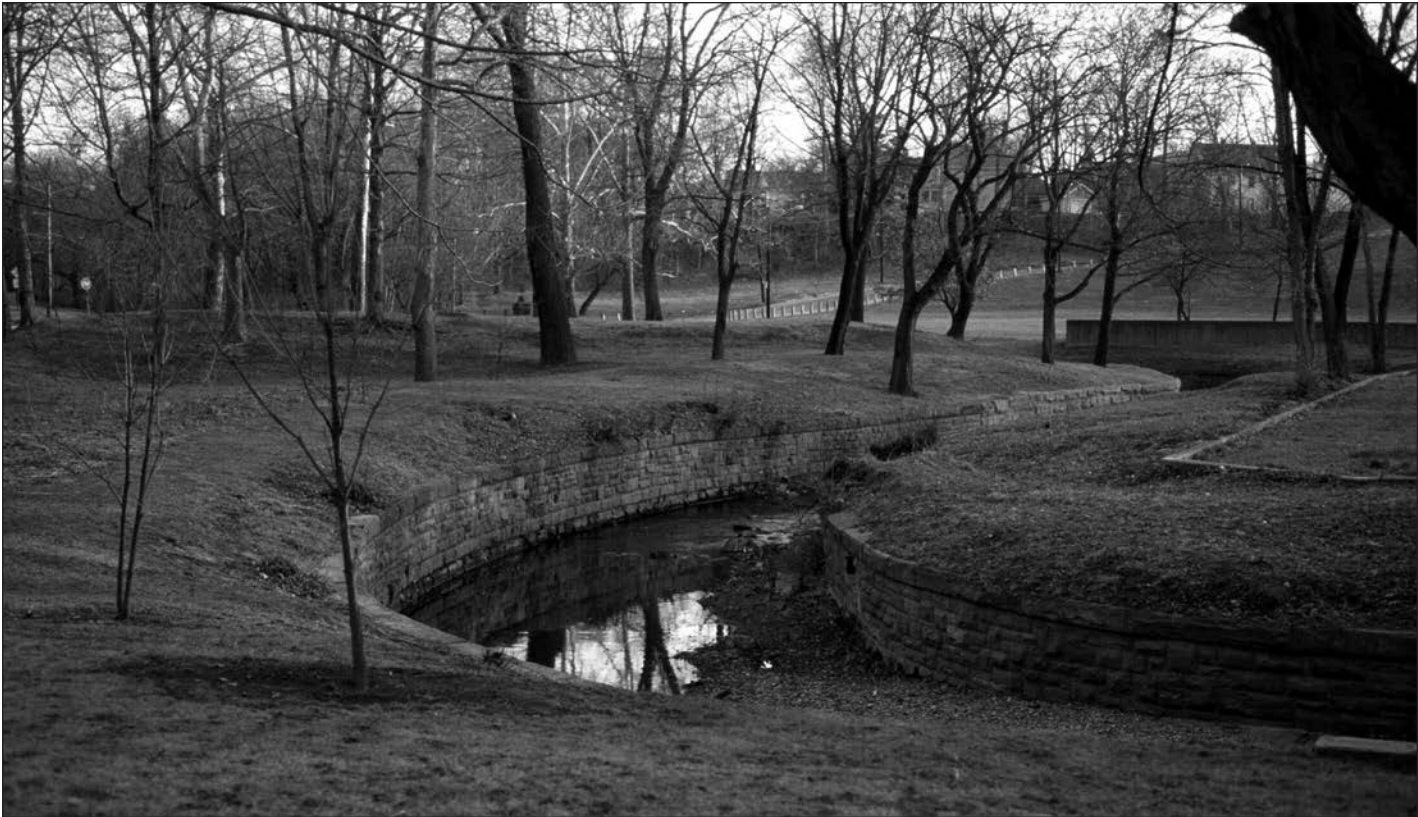
Channelized section of Doan Brook in Rockefeller Park. Photograph by L. C. Gooch.

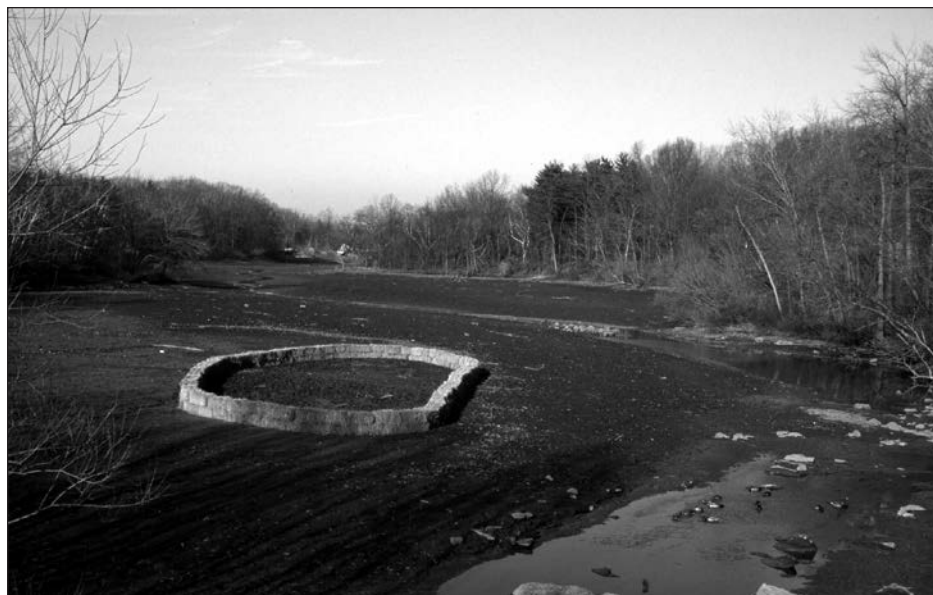
**Figure 6-1** Lower Shaker Lake when the lake was drained in 1998, looking west from the Larchmere Road bridge. Lake drainage revealed deep sediment deposits and a great deal of trash. Hay bales near the center of the picture were placed to protect the mud flat at the lake's east end. Photograph by L. C. Gooch.

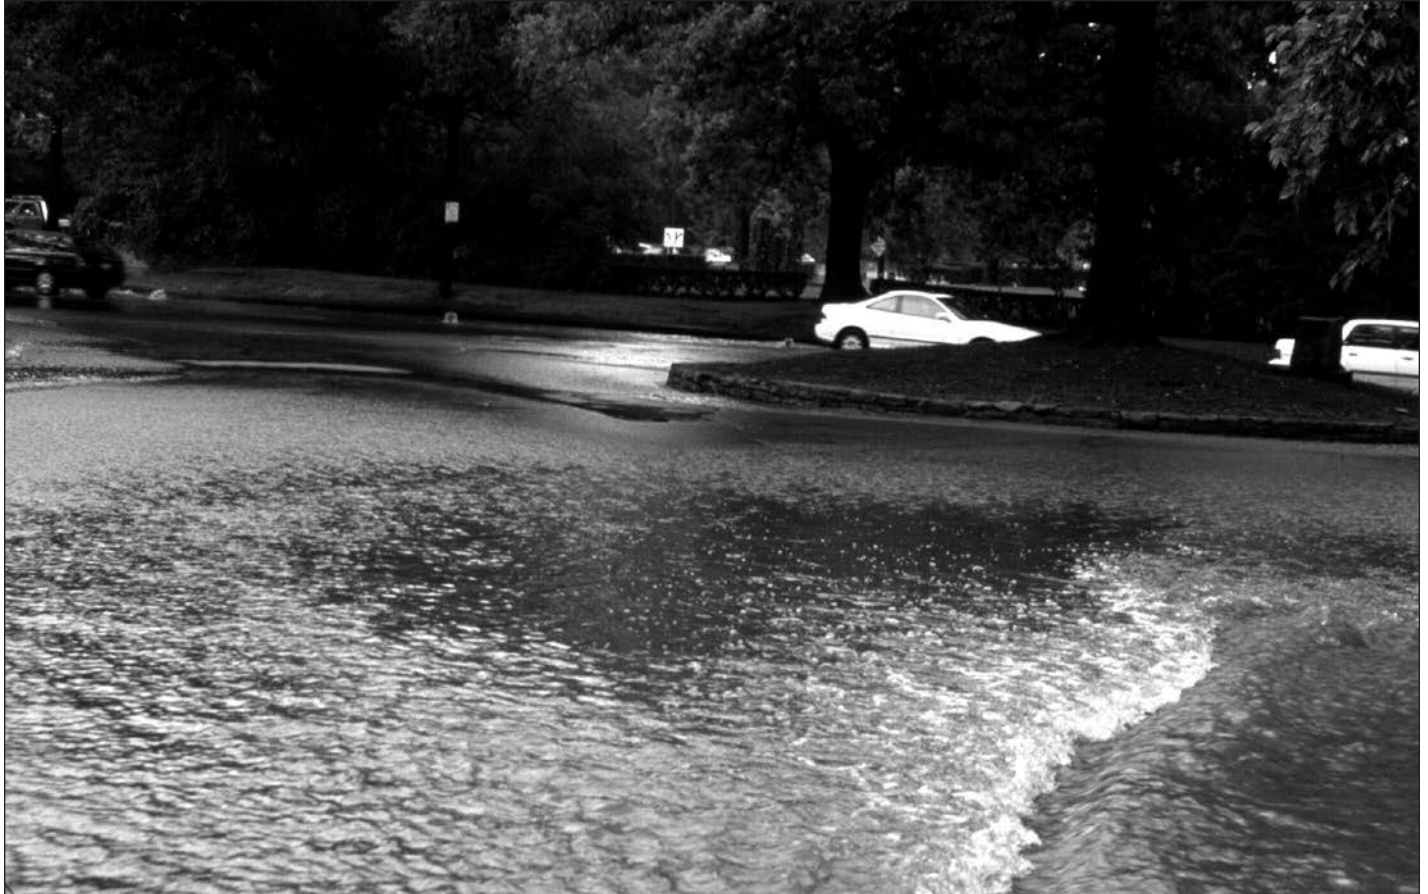
The Lower Shaker Lake dam overflows into North Park Boulevard. August 31, 2001. Photograph by L.C. Gooch.

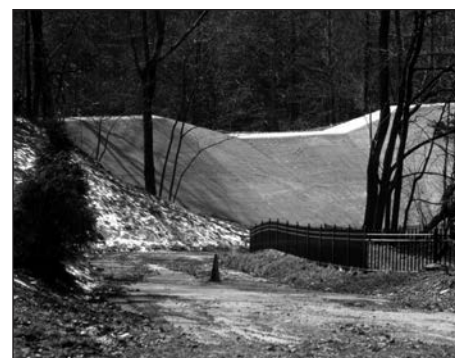
**Figure 7-3** The flood detention basin on Doan Brook just downstream from Martin Luther King, Jr., Boulevard. Photograph by L.C. Gooch.

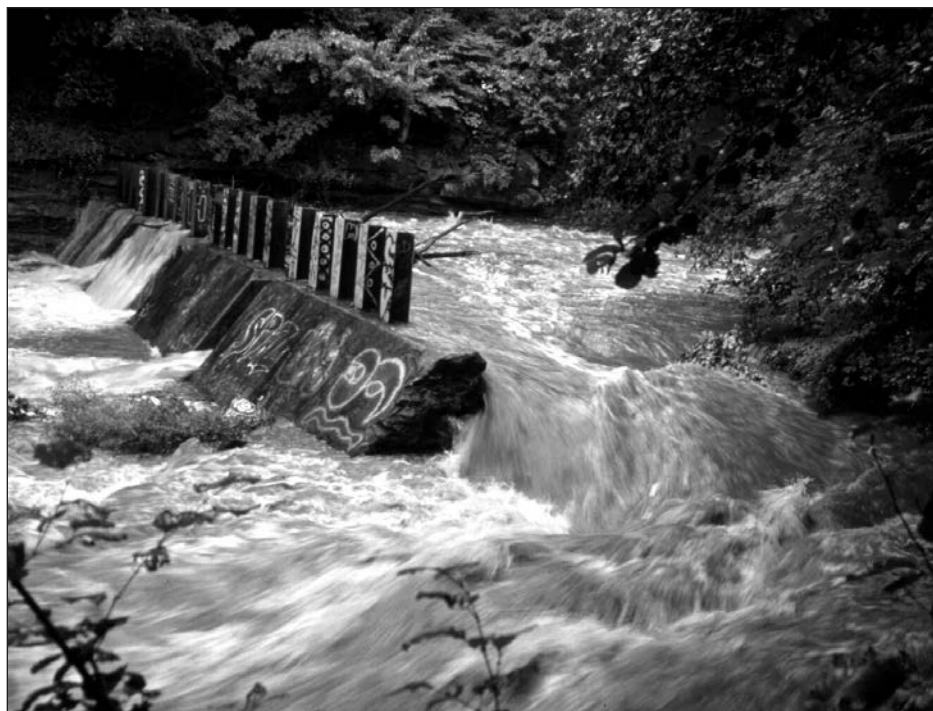
**Figure 7-4** Erosion around the end of the trash rack upstream from Martin Luther King, Jr., Boulevard is one result of high flows in Doan Brook. Photograph by L. C. Gooch

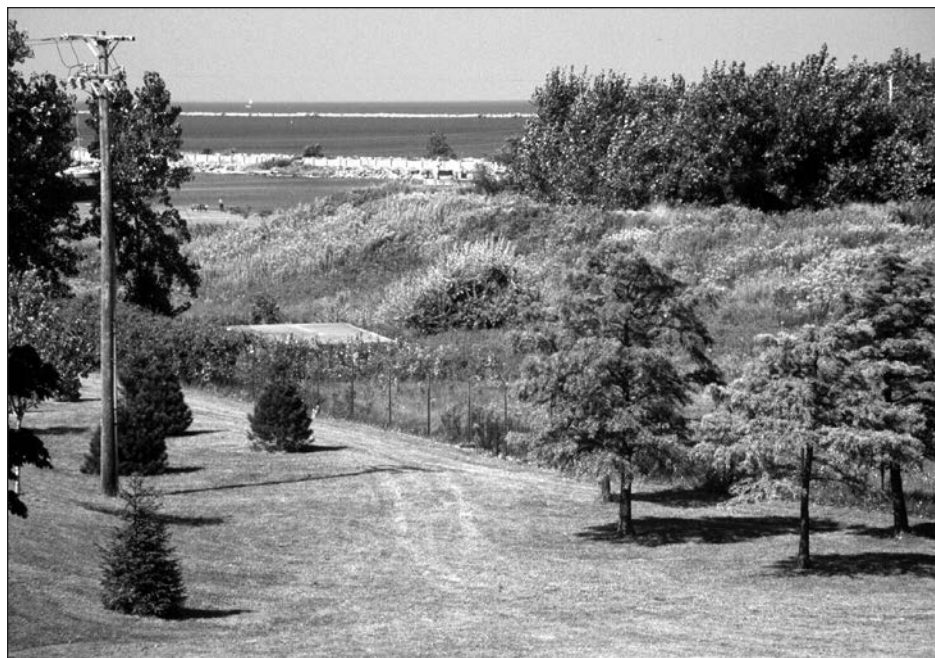
**Figure 8-2** The Site 14 dredge spoil disposal area at the mouth of Doan Brook has become outstanding migratory bird habitat. Preservation of this habitat could be part of Doan Brook restoration. Photograph by L. C. Gooch.

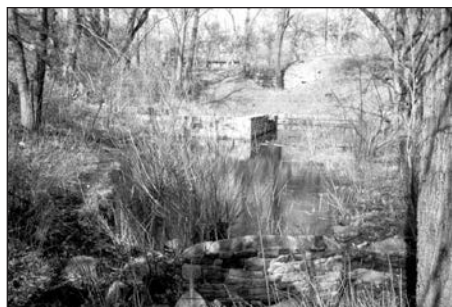
**Figure C-2** Shaker sawmill ruin and site of later wildflower garden. Just downstream from the Lower Shaker Lake dam — May 1966. Photograph by M. E. Croxton? From the Nature Center at Shaker Lakes collection.

The Shakers' original sawmill lay just downstream from the Lower Shaker Lake near the north end of the current dam. The sawmill sat in what is now a depression between the road along the dam and Coventry Road. Water that flowed across the mill wheel continued downstream from the mill in a channel (the mill race) that is now blocked by Coventry Road. You can find the remnant of the channel (almost dry now that it is cut off from the lake) by crossing Coventry and exploring the area between Fairmount and North Park. The abandoned mill race channel rejoins the channel

from the Lower Shaker Lake spillway a bit downstream (between the intersections of Demington and Woodmere with North Park).

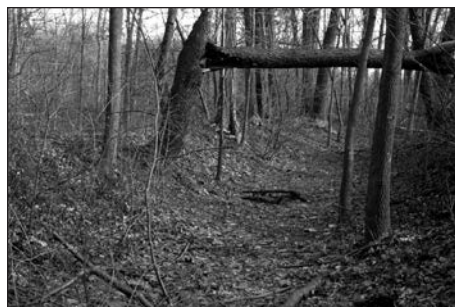
**Figure C-3** Remains of the earth channel that once carried a wooden flume along the south side of Doan Brook between Horseshoe Lake and the Shaker woolen mill near South Park Boulevard and Lee Road. Photograph by L. C. Gooch.

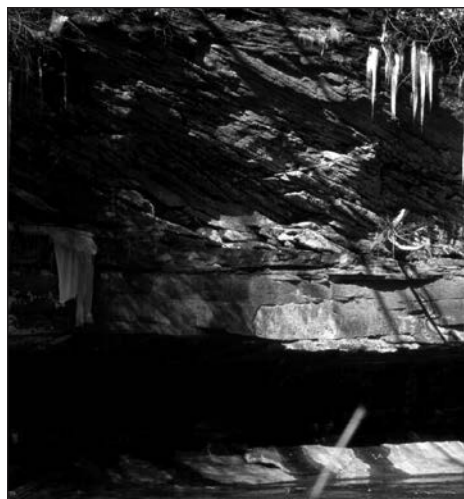
**Figure F-4** Berea Sandstone in the Doan Brook gorge, showing massive bedding along the brook and thin, cross-bedded layers above. Photograph by L. C. Gooch.
