**Doan Brook-Frontal Lake Erie ([04110003 05 04](#))
Nonpoint Source Pollution Implementation Strategy (NPS-IS)**

Version 1.0

Approved: February 26, 2019

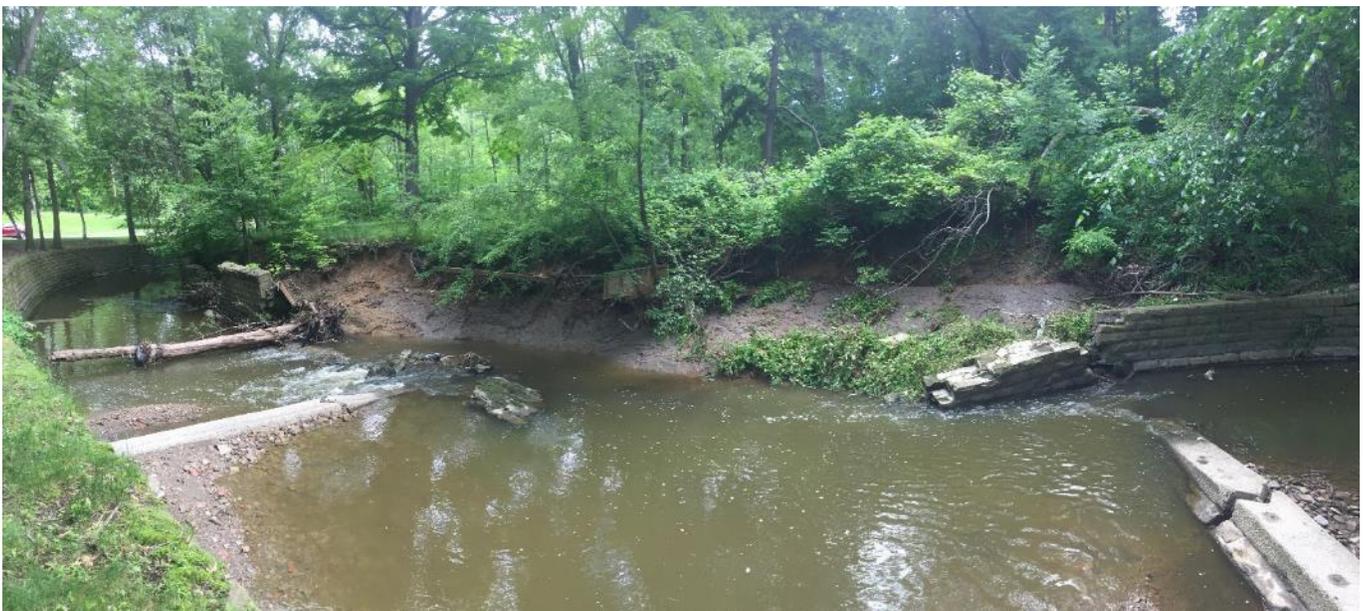
Figure 19: Doan Brook downstream of Wade Park Ave w. failing retaining walls (Photo taken June 4, 2018 by Alicia Beattie).

Table 6 lists the causes and sources of HUC-12 water quality impairment as identified in the Ohio EPA’s 2016 Integrated Water Quality Monitoring and Assessment Report. All of the identified causes and sources of impairment are associated with the heavy urban and suburban development throughout the HUC-12. Development patterns in Critical Area 1 (Doan Brook) are consistent with the rest of the HUC-12. From the headwaters to the mouth at Lake Erie, the Doan Brook flows through dense, urban and suburban areas with high levels of impervious surface area and aging storm water/sewer infrastructure. Urban runoff from the roadways, parking lots, buildings, and lawns of Cleveland, Cleveland Heights, and Shaker Heights are a major concern for Doan Brook as they contribute to flashiness and transport harmful chemicals and nutrients into the stream ecosystem. Similarly, CSO outfalls are major contributors to the contamination of the stream. In Cleveland, the Doan Brook is almost entirely disconnected from its floodplain as it either flows through culverts or is channelized in historic retaining walls. This negatively impacts stream habitat and flow regimes.

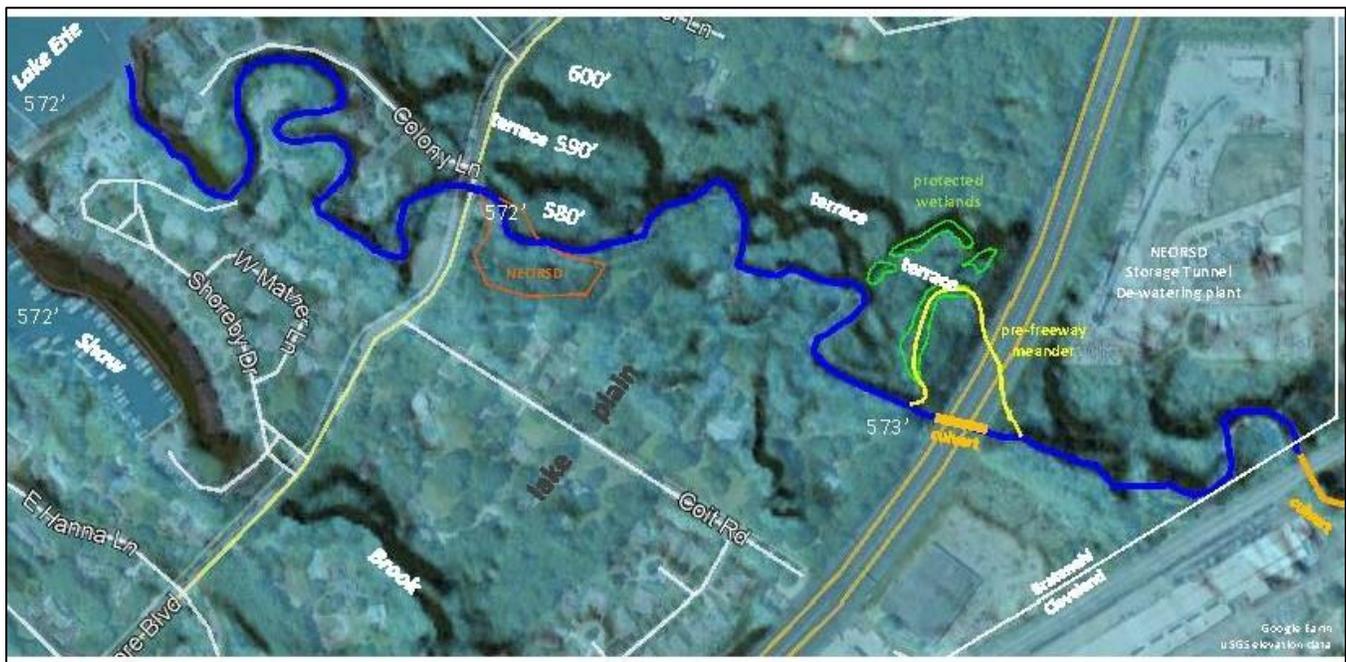
Figure 23: Nine Mile Creek Southside vicinity (between Lakeshore Boulevard and Interstate 90)

South of Interstate 90, the mainstem of Nine Mile Creek is free of culverting for 1.5 river miles to Lake Erie (Figure 23). Currently, the estuarine area begins at RM 0.3, approximately at the Lakeshore Boulevard crossing. Downstream of Lakeshore Boulevard, the historic meanders have been hardened as landscape features. Upstream of Lakeshore Boulevard (south of Interstate 90), Nine Mile Creek exhibits meanders and its floodplain has been preserved in a more-or-less natural state.

Between Interstate 90 and Lakeshore Boulevard, Nine Mile Creek's riparian zone has been largely preserved. Approximately 40 acres have been owned by one family since the 1880s and is known as Southside. Never subject to infill, the Southside ravine retains a well-developed terrace perched midway (elevation of approximately 590 feet) between the current floodplain (elevation of approximately 580 feet) and the lake plain rim (elevation approximately 600 feet) (Figure 23). Wetlands are found in meander scars on the terrace and floodplain. Logged just once, the Southside property contains the only sizeable beech-oak forest on the lake plain in Cuyahoga County. In 2011, the family placed 28 acres under a conservation easement held by Western Reserve Land Conservancy. As part of the conservation plan, NEORSD, EnviroScience, Inc., and the landowner share responsibilities for wetland enhancement and invasive species control on the property.

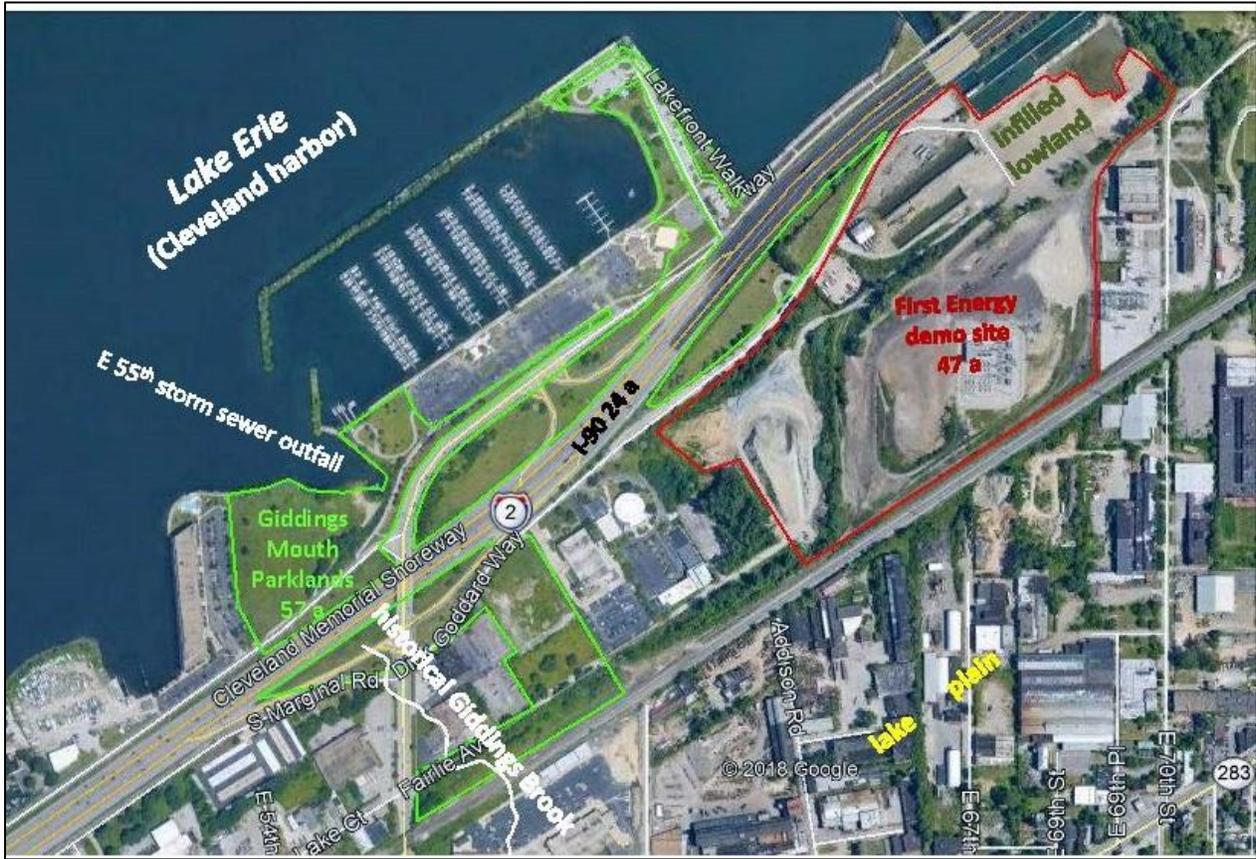
Figure 25: Parklands near mouth of Giddings Brook

The Giddings Brook outfall is surrounded by 57 acres of sparsely wooded parkland, Interstate 90 marginal areas, and various abandoned (unmown) private properties (Figure 25). Cleveland Metroparks manages the non-road parklands as part of the East 55th Street Marina. The East Shoreway (Interstate 90 and State Route 2) contributes significant impervious cover draining to this outfall (approximately 1.1 miles and 24 acres of paved surface). An associated interchange, marginal roadways and a few side streets contribute approximately an additional 2 miles of pavement and bring the local impervious surface area to greater than 30 acres.

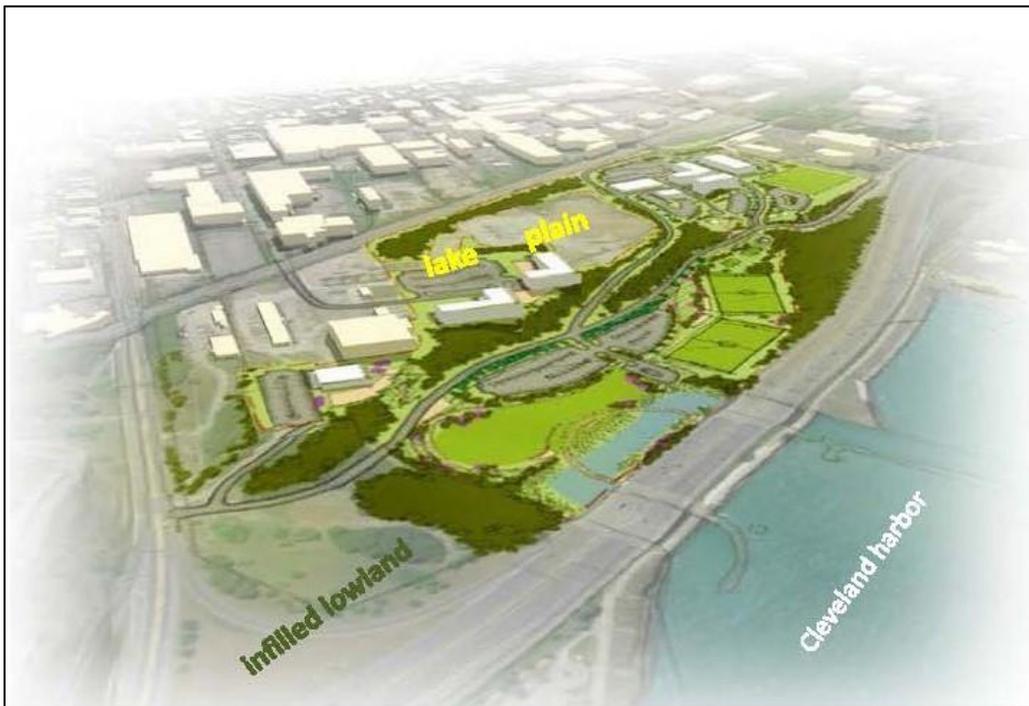
Figure 26: CallisonRTKL Public A scenario for FirstEnergy demolition site (facing southwest)

An adjacent 54 acres includes the site of the demolished (in 2017) FirstEnergy lakefront power plant. FirstEnergy remains the landowner and is evaluating future plans for this property. One plan, entitled Public A (prepared by CallisonRTKL), features nearly 20 acres of proposed urban woodland (Figure 26).

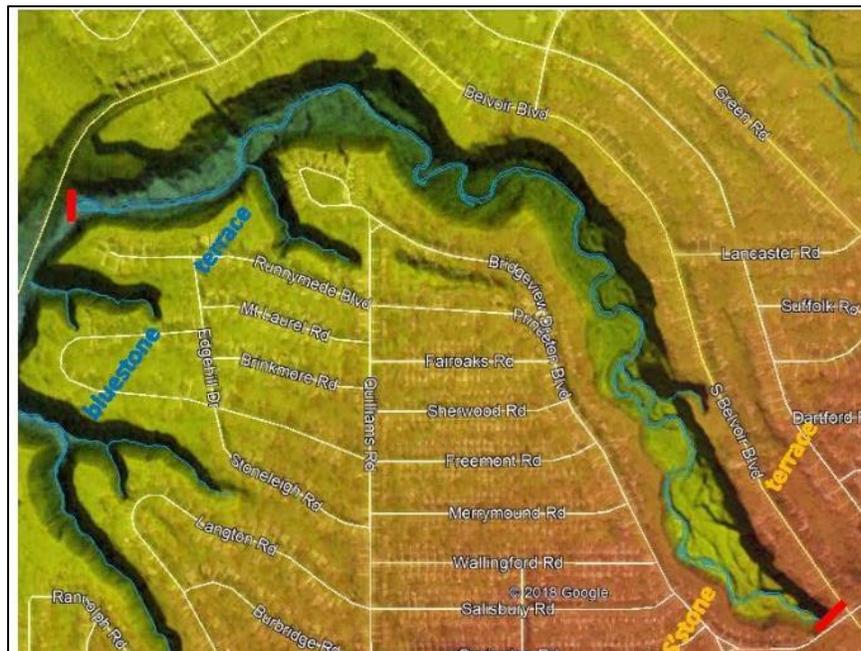
Figure 28: Nine Mile Creek escarpment ravine

Nine Mile Creek between Princeton and Belvoir Boulevards is surrounded by 39 acres of forested floodplain; however, the stream does not have access to its floodplain in all areas due to incision. This reach is characterized by alternating sections of scoured bedrock and gravel/cobble depositional bars, likely a result of flashy stormwater flows and lack of floodplain access through this open segment.

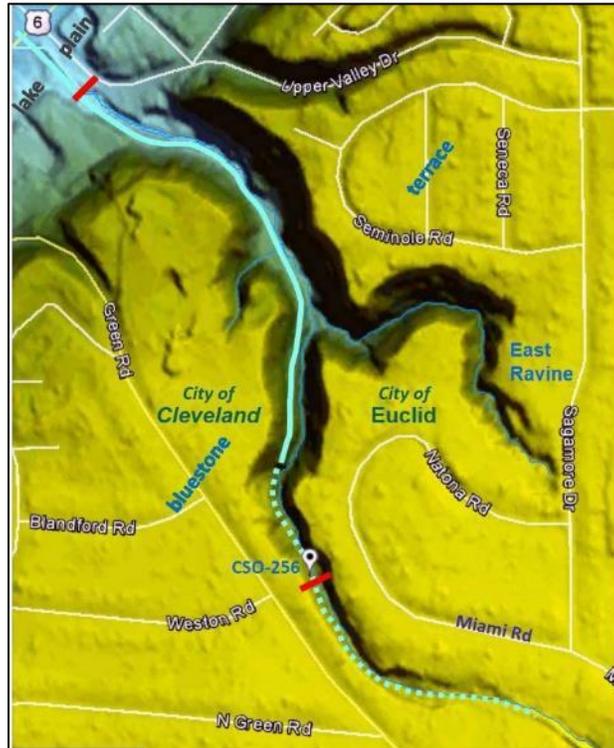
Figure 29: Green Creek escarpment ravine

In 1883, the Euclid Railroad short line was built to bring products from the Nine Mile and Euclid Creeks sandstone quarries to the Nickel Plate Road on the lake plain. The Green Creek escarpment ravine provided a relatively gentle traverse through the steep lower escarpment face. The railroad was abandoned in 1967 and the facility quickly deteriorated. The railbed terrace within the area of steepest stream gradient is now slumping into the stream course. As flashy stormwater flows undercut the streambanks, this slumping and erosion contribute fine materials (silt, clay, gravel, and coke slag) into the streambed which inhibit stream flow and impair aquatic habitat.
