DAM SAFETY INSPECTION REPORT

Lower Shaker Lake Dam

File Number: 1314-001

Inspection Date: September 30, 2014

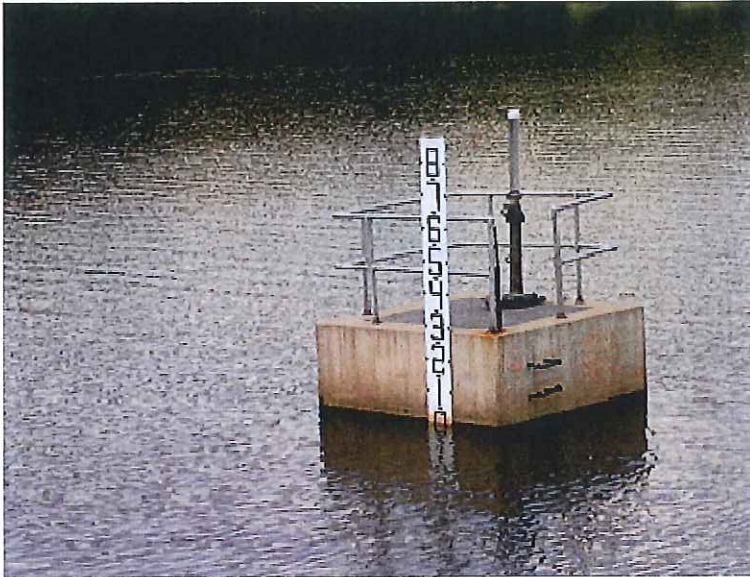
A. A staff gauge helps the owner more accurately document pool levels during flood events and during routine inspections. It is very helpful to correlate seepage through drains to pool level. Please note that the graduations/numbers should extend beneath the lake level so that lowering of the pool (should it be needed or desired) can be monitored. It should be positioned to allow easy reading from a safe location. An example of a staff gauge is shown below.

1. It is highly recommended that a staff gauge be installed on the principal spillway. Please note that the graduations should extend below the normal pool level to allow monitoring during drawdowns. See Discussion Item A in this section for additional information.
2. Due to the severe deficiency of this dam to be able to pass its design flood, the stop-logs in the principal spillway must be removed. See Discussion Item B in this section for additional information.
