# DOAN BROOK WATERSHED ACTION PLAN

## DOAN BROOK WATERSHED PARTNERSHIP

**March 2013** *(updates December, 2013)*

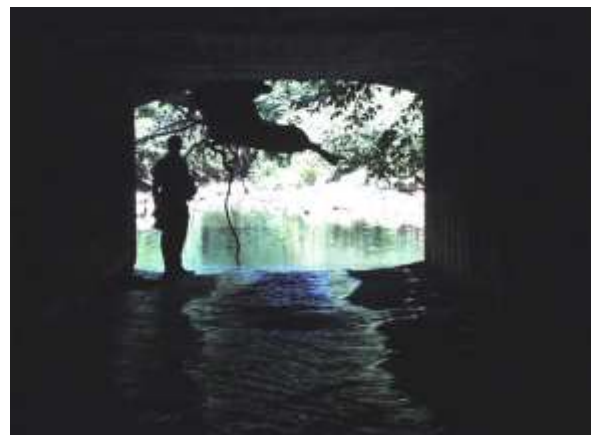
The Brook is completely culverted under University Circle, traveling 5,160 linear feet underground. This is a primary inhibitor of watershed health and daylighting the stream would provide one of the most significant opportunities for improvement, should funding become available. Due to the high cost of daylighting urban streams, it is highly unlikely that the University Circle culvert will ever be unearthed in one project. A stronger possibility

is for the culvert to be slowly removed, small project by small project. University Circle, with its large number of community institutions and underlying sandy soils, is an optimal place to mitigate for impervious cover with stormwater control measures.

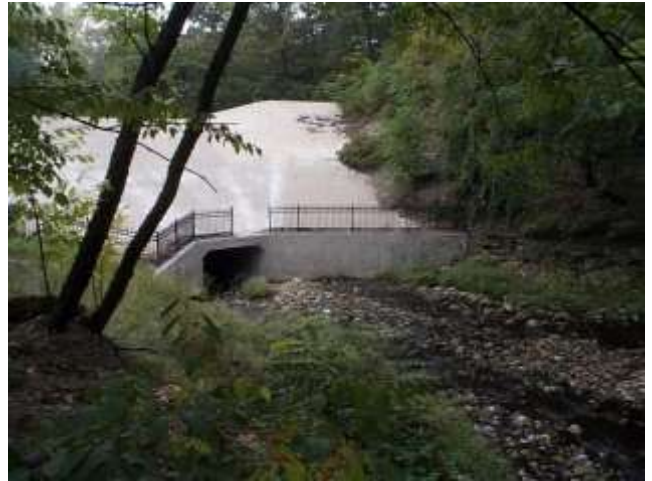
The Doan Brook gorge connects the upper and lower sub-watersheds. It is comprised of steep terrain and is dominated by natural forested riparian corridor. The gorge showcases Doan Brook's natural waterfalls and deep ravines. Its waterfall, albeit natural, does restrict fish migration from the upper to the lower part of the watershed. A large detention dam was built by the City of Cleveland immediately downstream of the gorge, where the stream enters Ambler Park. The stream drops into the University Circle culvert in Rudy Rogers Scout Park through Ambler Park in this subwatershed.

- Amphibian and fish species diversity is poor and lacks common stream-side species.
- Bank erosion at the downstream end of the gorge exists.
- In a year with typical rainfall, there are overflows from two CSO's, numbering approximately 16 times.
- An abundance of Japanese knotweed is found in this reach.
- Low base flows downstream of the Lower Shaker Lake contribute to poor fish diversity.
- The detention basin downstream of the gorge is improperly located to maximize its flood control function.

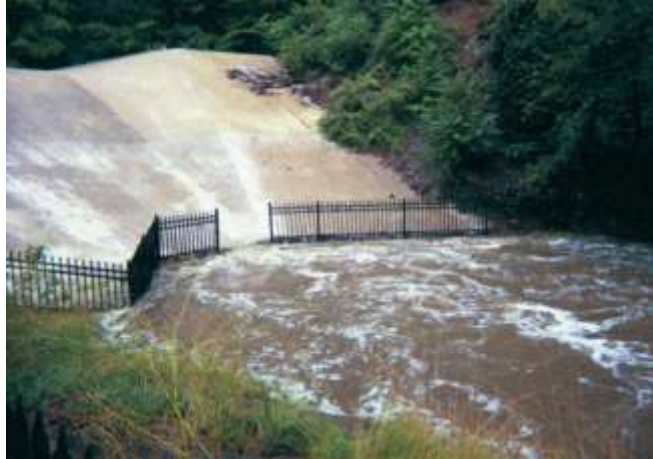
There are five dams in the watershed. Four of the dams form the lakes in the upper watershed; Horseshoe, Lower Shaker, Marshall and Green. The fifth is the Ambler Park detention dam located downstream from Martin Luther King Boulevard. This dam was installed in 1997 to create a flood detention basin and does not form a permanent lake.

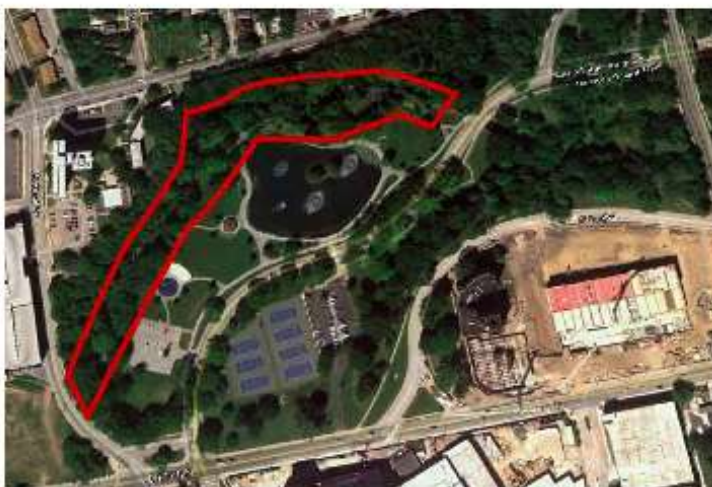
The red line indicates the project limits as of August 24, 2011.
